## Hot dip galvanizing Repair system

# G-SAVE

## Repair Status of HDG [ex] Guard rail

## Touch up for HDG damaged point [G.SAVE Can spray]

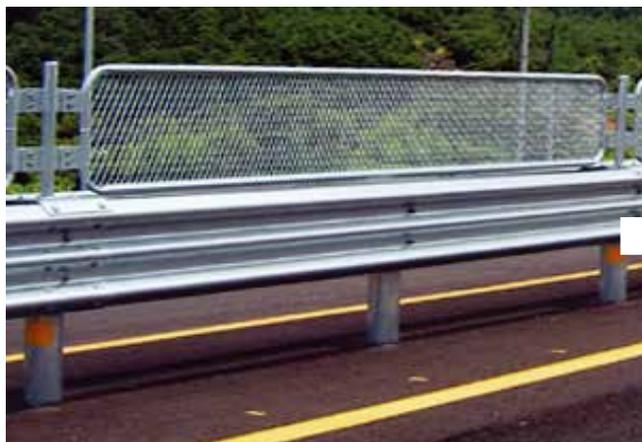
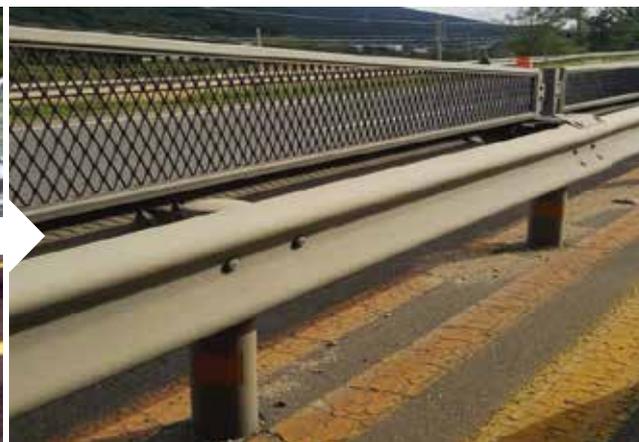
Corrosion resistance	HDG repair SST 1000hr
Coating method	Air spray(HVLP), Roller
Working Condition	Room temp. Substance temp. : -5°C~40°C
Dry Condition	Natural dry
	Touch dry within 10min (15~25°C)
Color	Silver

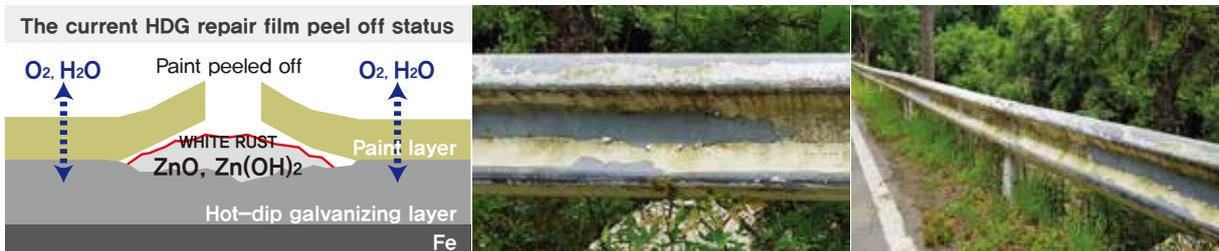
HDG guard rails replace the entire guard rail irrespective of the function of the original steel plate when the plated layer functions.

Functionally, there is no problem, but we have replaced some or all of the sections of the guard rail, which is discolored (blackened) by galvanized plating, for road (city) aesthetics.

repair the HDG using organic paint, the white rust will push up the organic paint and peel off the coating within 2 ~ 3 years. Currently, organic paint is not being repaired.

HDG re-plating is not possible. (Disassembly, plating, re-installation is not economical)

Metal paint coating (such as Geomet) is not possible to dry on site. (Heat treatment at 320 degrees for 30 minutes twice)

Powder coating can not be dried on site. (Heat treatment at 200 degrees for 20 minutes)

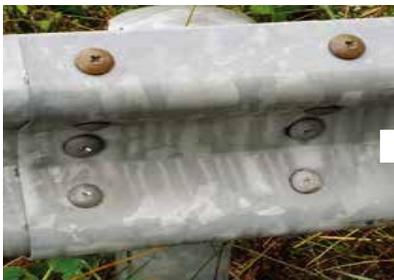
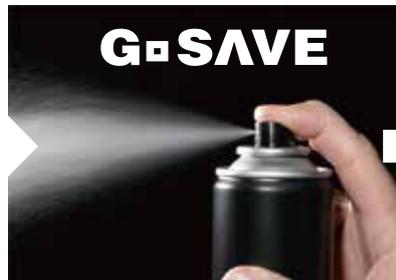
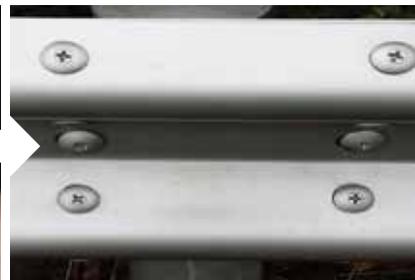
Corrosion resistance	HDG repair SST 700hr
Coating method	Spray
Working Condition	Room temp. Substance temp. : -5°C~40°C
Dry Condition	Natural dry
	Touch dry within 10min (15~25°C)
Color	Silver
